The medieval peasant building in Scotland: the beginning and end of crucks

Piers Dixon

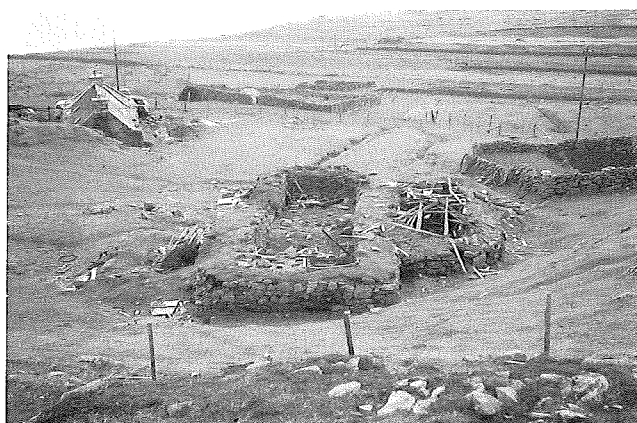
Fig. 3. A blackhouse at Carlaway, Lewis with a subsidiary cell. Crown Copyright RCAHMS.

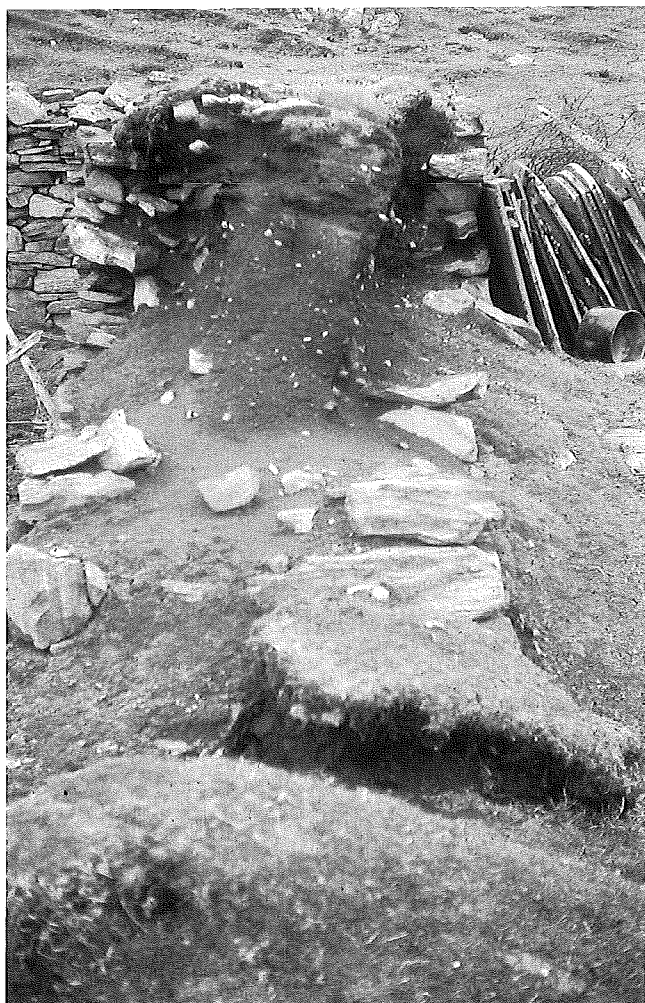
Fig. 4. The so-called 'double-walled' construction in section from a blackhouse at Carloway, Lewis, showing the earth core. Crown Copyright RCAHMS.

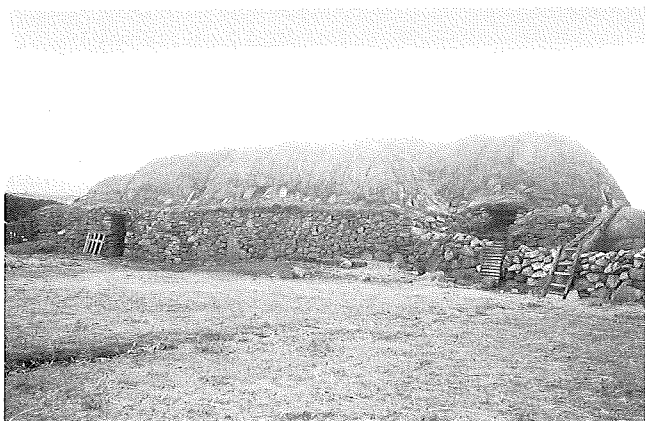
Fig. 5. View of a blackhouse at Carloway, Lewis showing the hipped roof resting on the inside of the walls. Crown Copyright RCAHMS.

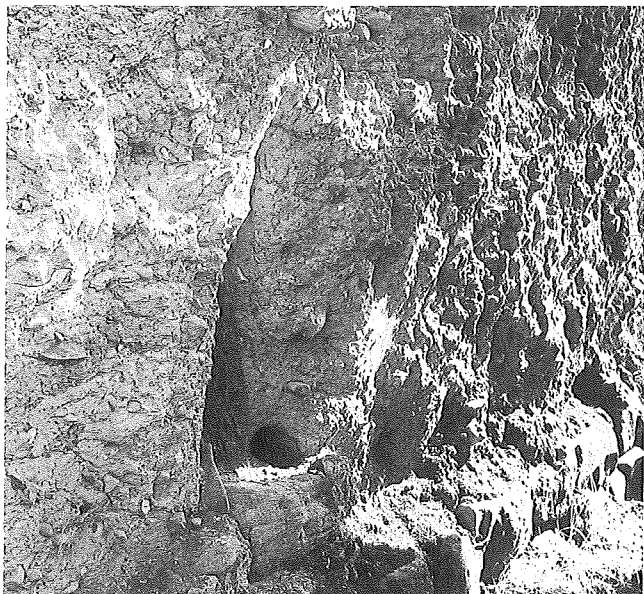
Fig. 6. A padstone foundation for a cruck within the clay wall of the cruck-framed barn at Prior's Lynn, Dumfries-shire. Crown Copyright RCAHMS.

Two main types of cruck blade are to be found; the paired single blade: sometimes split from the same log; and the jointed or multiple-jointed blade. The cruck-truss may either be open or closed. It is closed if the cruck blades are crossed at the top to provide a seat for the ridge-tree, or open if the blades are joined to a collar yoke upon which the ridge tree sat, sometimes on a supporting chock. The length of the collar can be a device for broadening the width of the truss and hence the width of the house, particularly where longer timbers cannot be obtained. The feet of the crucks were founded either on a stone pad within the wall (e.g. Prior's Lynn, Dumfriesshire, Fig. 6), or on the ground, whatever the wall material.

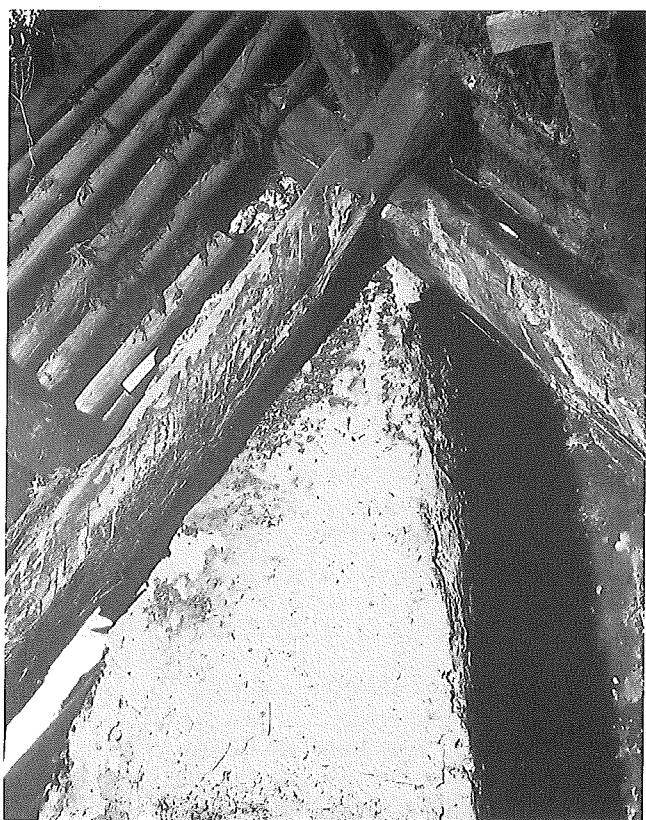
Fig. 7. A closed single-blade cruck at Achcullin, Inverness-shire showing the crossed apex for the ridge-tree. Crown Copyright RCAHMS.

An example of a closed single blade cruck is the croft house at Achcullin, Inverness-shire, where the birch blades cross at the apex to form a fork that supports the ridge (Fig. 7). There is also a fine example of an open cruck truss at Prior's Lynn, Canonbie, Dumfriesshire, where the oak blade of the crucks are

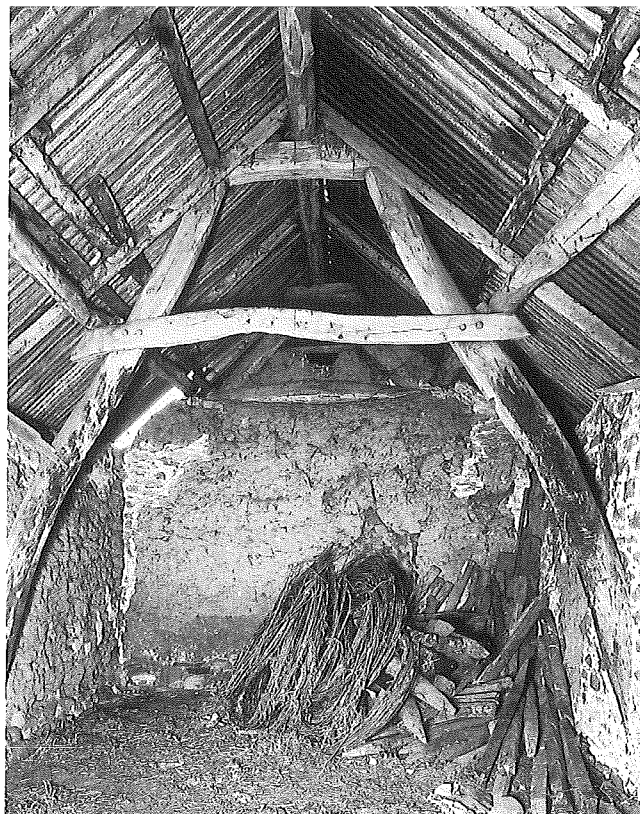
Fig. 8. The interior of the cruck-framed barn at Prior's Lynn, Dumfries-shire showing the open oak single-blade cruck construction. Crown Copyright RCAHMS.

tenoned into a saddle collar that supports the ridge purlin (Fig. 8). This building was a clay-walled barn and store (Stell 1972). The byre-house at Torthorwald, Dumfriesshire, with three oak crucks has a similar style of cruck-truss (Stell 1972, and Fig. 1). Sometimes the collar is so wide that an additional upper truss is

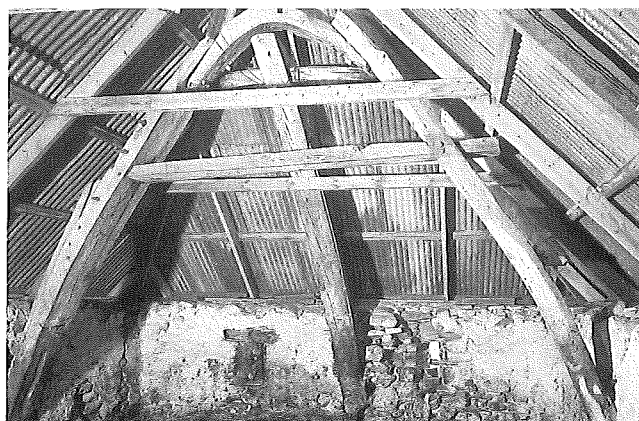
Fig. 9. The interior of the hipped cruck-framed barn at Corrimony, Inverness-shire showing the end cruck. Crown Copyright RCAHMS.

barn, Inverness-shire, which comprises cruck-trusses with an overall span of 19 feet (5.5 m) - the widest cruck span that is known to have survived (*Fig. 9*). The roof was hipped and was supported by a single cruck blade at each end (a 'gavel-fork'). In the original configuration, the roof purlins were supported on the projecting ends of the collar and the spurs jointed into the cruck blades lower down, while a sill-beam was pegged close to the foot of the blades. The present mortared stone walls are a modern replacement. Unusually, the heads of the crucks were scarfed to a curved, hairpin yoke, to create an architecturally refined example of a cruck building. The curvature of the crucks, the peg-holes near the foot of the cruck

blades and the short size of the spurs, suggest that the walls must once have sloped inward (*Hay 1973*). This could not be easily achieved with most building materials, and it is thought likely that it must have been a creel house with a light turf covering.

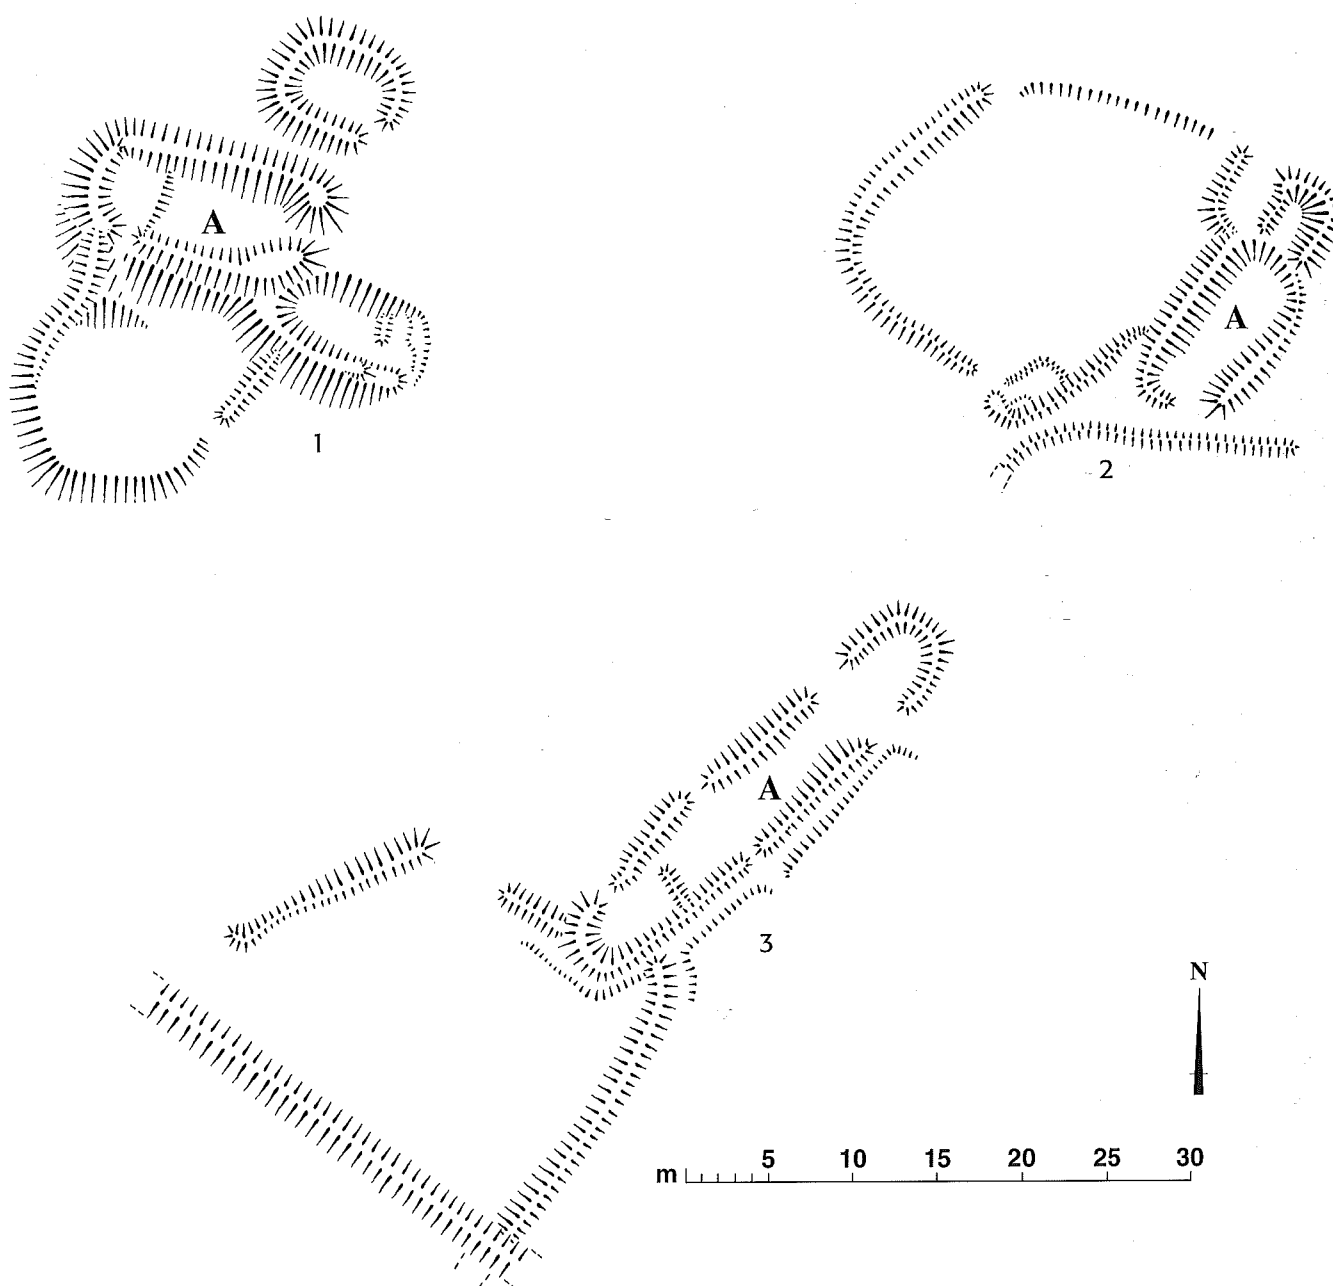
Fig. 10. Plans of the medieval farmsteads at Southdean, Roxburghshire. Note the outbuildings in two cases (1,2,) and at the third (3) a barn and byre-house under one roof. Crown Copyright RCAHMS.

Although many buildings reduced to grass-covered foundations have been recorded throughout Scotland, clear-cut evidence of their construction and function is meagre. Out of 4000 buildings examined over six years of fieldwork by the RCAHMS between 1990 and 1995 less than 50 can be defined as byre-houses on the basis of the distinctive drain or sump found at one end of a building. About 800 had signs of sub-division suggestive of functional differences, but not of the functions themselves. However, there is another group of buildings, which are found in Sutherland and Skye which may also qualify as byre-houses (RCAHMS 1993a; 1993b). They are built so as to lie down-slope, with the lower end having an opening in the middle of the gable wall - presumably to allow the waste to run-off from the cattle. Likewise, in the Cheviots and southern uplands there are byre-houses, which are levelled into the rising ground and display a hollow in one end of the building, or an opening in the gable-end to allow the outflow from a sump. Examples of these may be seen at Southdean and Liddesdale, Roxburghshire and in Eskdale, Dumfriesshire (RCAHMS 1994; Dixon 1997; RCAHMS 1997). Evidence of barns is more difficult to pin down. Some buildings with opposed doors have been identified which might fall in this category, including one example in Southdean, Roxburghshire which had two sets of opposed entrances and a partition - suggesting a dwelling, a byre and a barn combined in one structure. However, farmsteads comprising a main building and one or more outbuildings are much more typical of southern Scotland (Fig. 10).

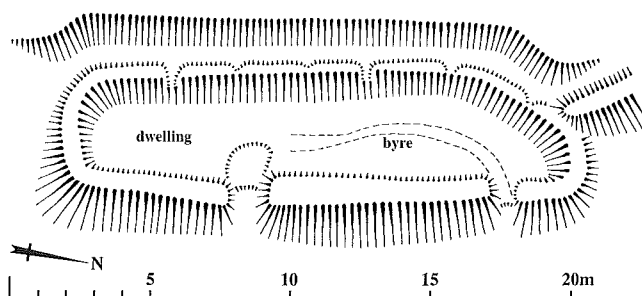
Fig. 11. The turf-walled byre-house at Quarterside of Lipney, Stirling showing the dips in one side wall, which may mark the location of cruck-slots. Crown Copyright RCAHMS.

The evidence of roofing is confined mainly to the observation of cruck-slots and cruck-blades in unroofed ruins. In only one instance can it be suggested from the grass-covered foundations that crucks may have been used in a building. At Quarter-side of Lipney, near Stirling, a house that was terraced into the slope displayed dips about 2 m apart in the wall at the back of the platform, which still stood to c. 0.5 m high (*Fig. 11*). Such a gap between couples is not unusual in cruck-framed buildings; but generally, grass-covered foundations cannot display any hint of how a building was roofed (*RCAHMS 2001*).

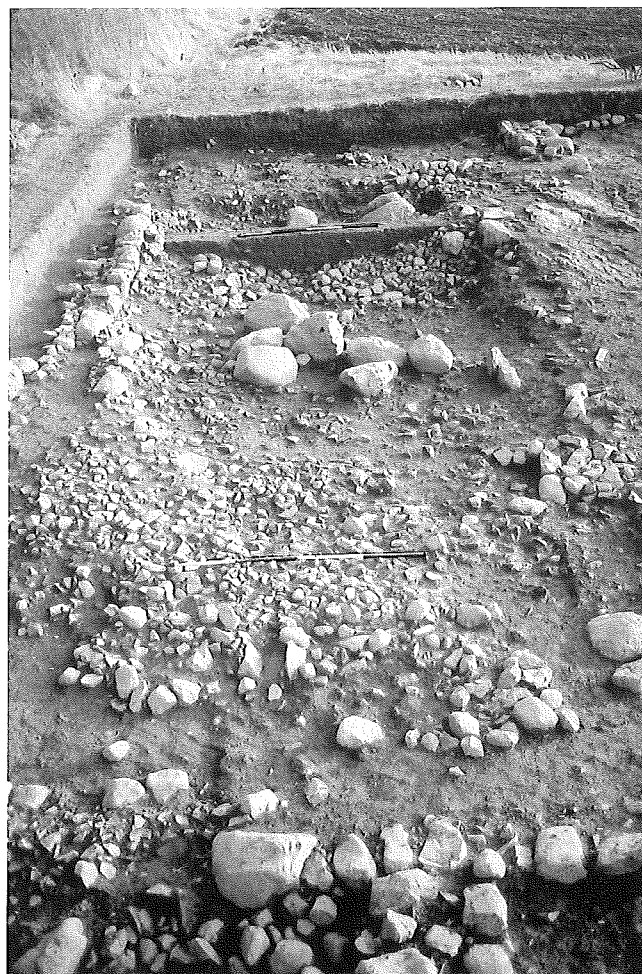
Fig. 12. View of the collapsed stone rubble aggregate from the clay walls of a 14th century house at Springwood Park, Kelso, Roxburghshire. Copyright Piers Dixon.

The houses of the 13th and 14th century were based on stone foundations standing between 0.3 m and 0.75 m high. These were the foundation for walls, comprising an aggregate of clay and stone (clay-boule, *Fig. 12*). The roofs of the buildings were supported on crucks. About one-third of the way along the side wall of one of the buildings there was a broken slab set in the wall-footing at about 50 cm above the floor - a fortuitous survival of a stone plinth designed to take a cruck (*Fig. 13*). Several other cruck plinths were located which included one that was set in a post-hole on a flat stone (*Fig. 14*); another that was set in a shallow hole in the corner of a building; and a third set on a pad-stone laid directly upon the ground. However, almost the full range of methods for the foundation of crucks was located at this site, and cruck-framed houses may be reconstructed (*Fig. 15*).

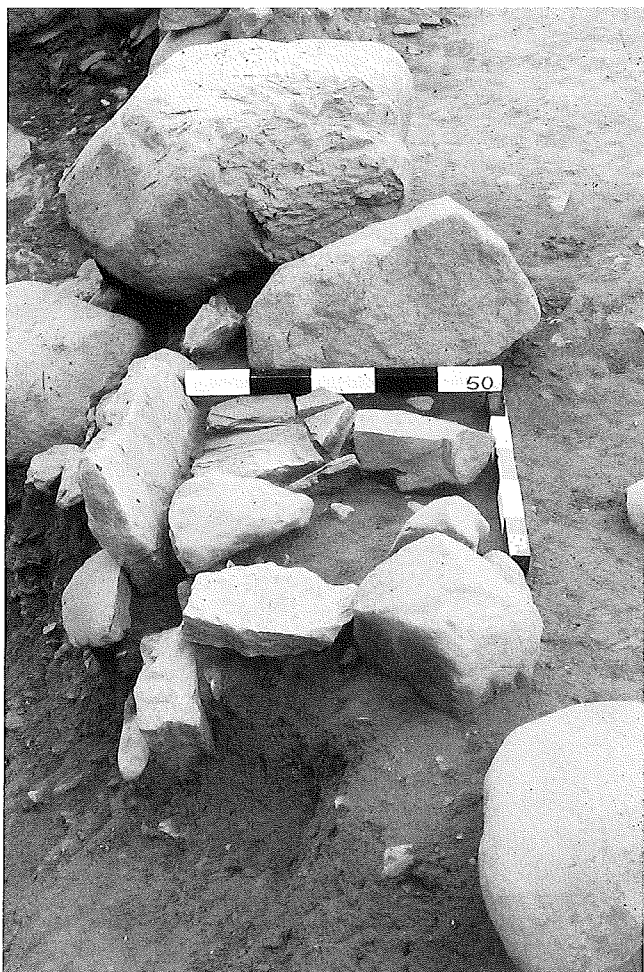
Fig. 13. View of the stone plinth in the wall of a 14th century house at Springwood Park, Kelso, Roxburghshire. Copyright Piers Dixon.

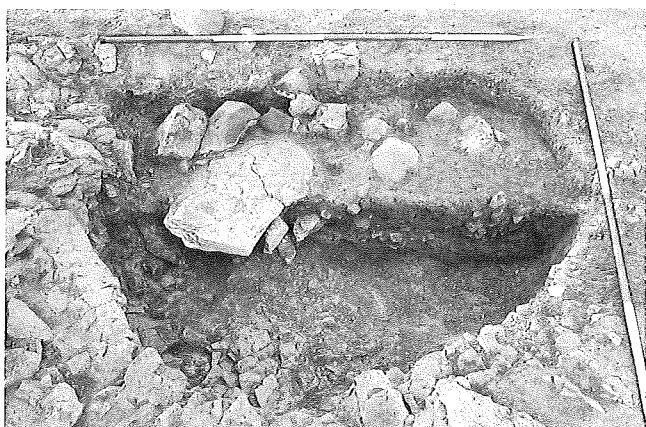
Fig. 14. View of the post-hole founded padstone for a cruck from a 13th century house at Springwood Park, Kelso, Roxburghshire. Copyright Piers Dixon.

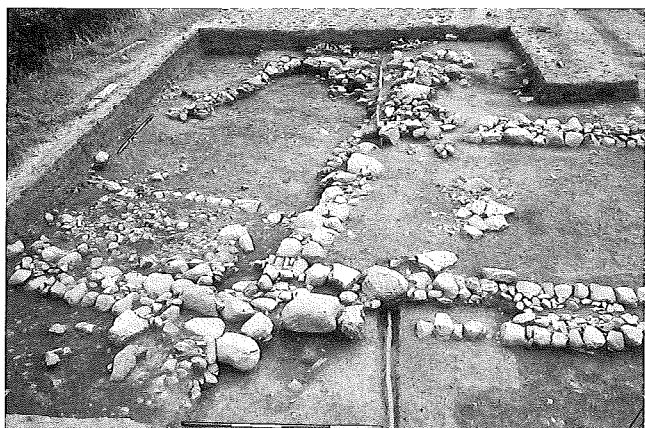
Fig. 16. A 14th century house at Springwood Park, Kelso, Roxburghshire showing the cobbled stand for horses. Copyright Piers Dixon.

house had a cobbled area at one end suggesting a sub-division of function (*Fig. 16*). While this section of the building could have been used as a byre, there was no open drain or sump. Although there was a stone covered drain in two of the houses, this suggests the stabling of horses - a finding that is supported by the discovery of horseshoes, and horse-shoe nails, and decorative horse-brasses. No hearths were encountered in this phase of occupation and it is therefore presumed that a brazier was used for cooking and heating. However, stone hearths and ash deposits were present in the earlier 13th century buildings, where there are no signs of any animal accommodation. At this time, the houses were divided by a timber partition.
