Greenland irrigation systems on a West Nordic background

An overview of the evidence of irrigation systems in Norse Greenland c. 980–1450 AD

Jette Arneborg

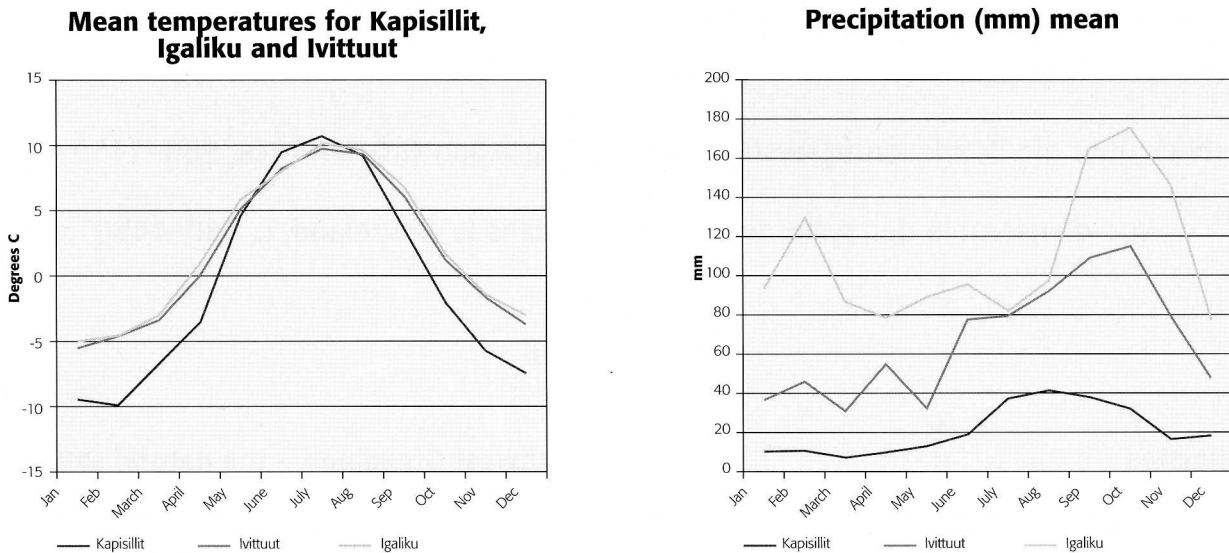
Fig. 3. Mean temperatures and precipitation in the period 1958–1999 for Kapisillit in the central part of the Norse Western Settlement and for Igaliku and Ivittuut in the central and northern part respectively of the Eastern Settlement.

The Icelandic colonists settled in Greenland at the peak of the Medieval Warm Period, and the climate at the time of the arrival is thought to have been warmer than the climate of today. The Medieval Warm Period is normally suggested to have lasted from c. AD 900 to c. AD 1350, when The Little Ice Age followed it (fig. 3).
